NextEra Energy Resources Generation Repair & Service Overview

November 15, 2013

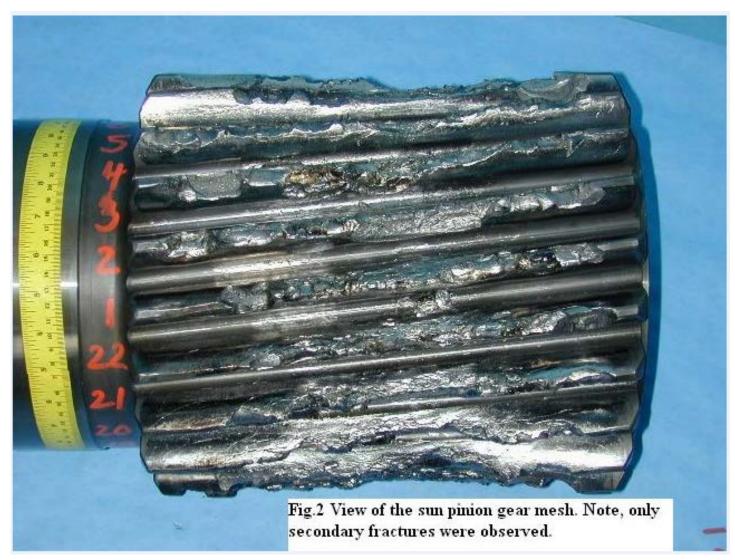
Ring gear pinion secondary damage from previous slide

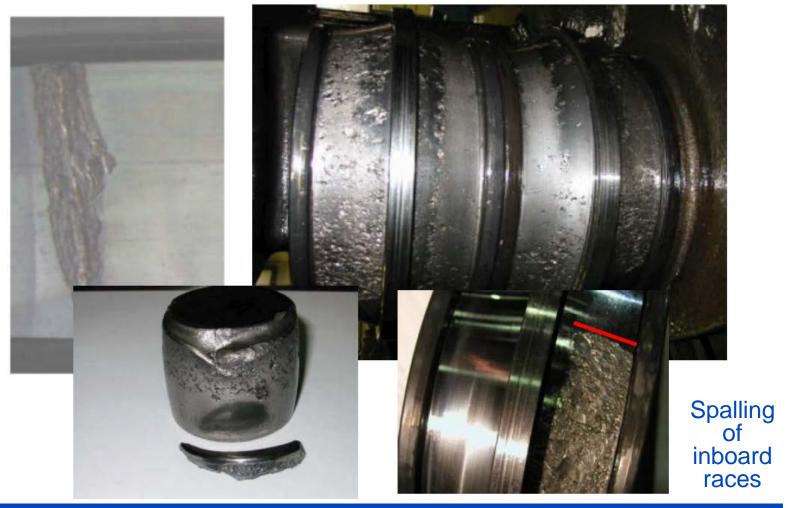
Macro pitting of a spherical roller planet gear bearing race

Typical bearing analysis, indications of overloaded bearing due to higher loads than expected. Bearing selections that work in other industry do not work in wind.

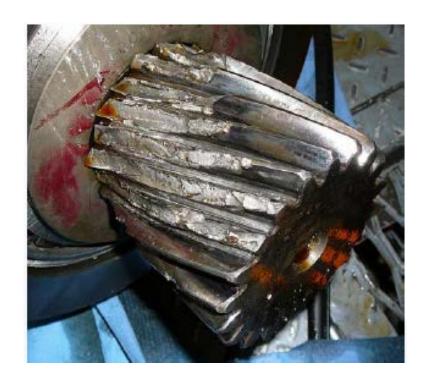
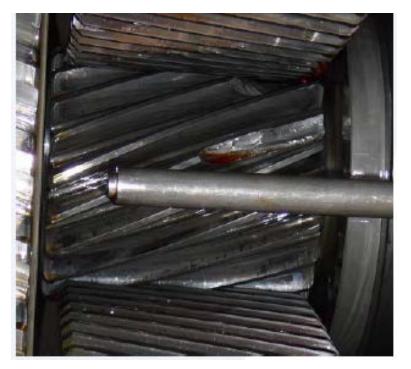
Gear tooth overloading associated with a tolerance problem

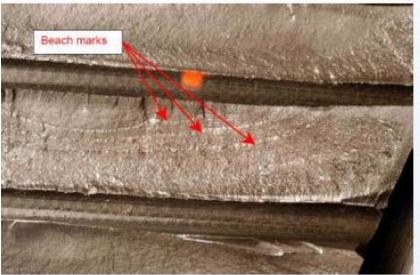
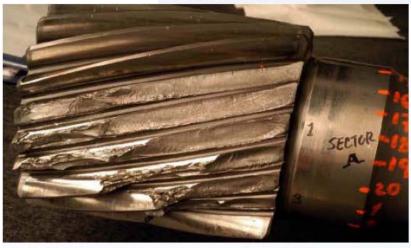
High cycle fatigue – wear over life of the component

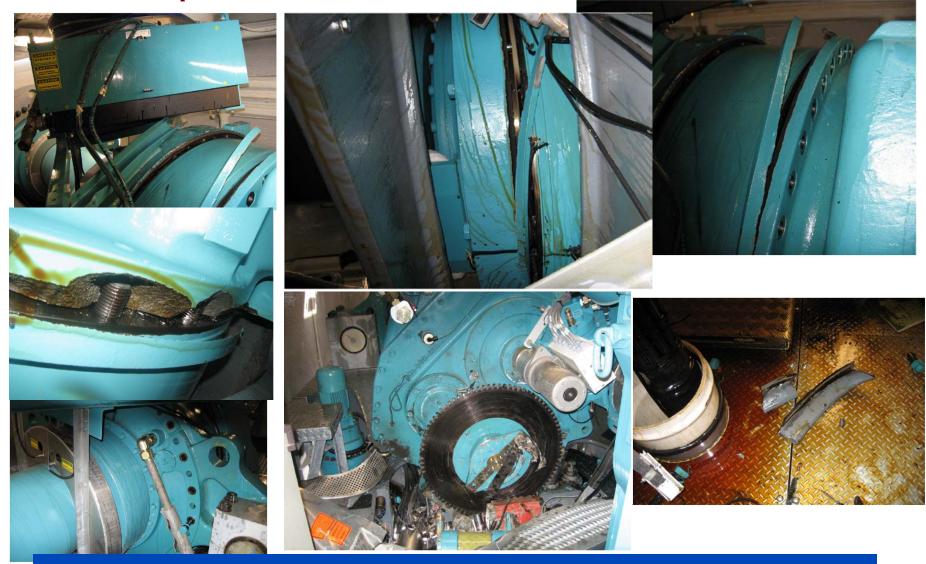
Catastrophic Failure

Salvage some gearing and send gearbox to scrap vendor

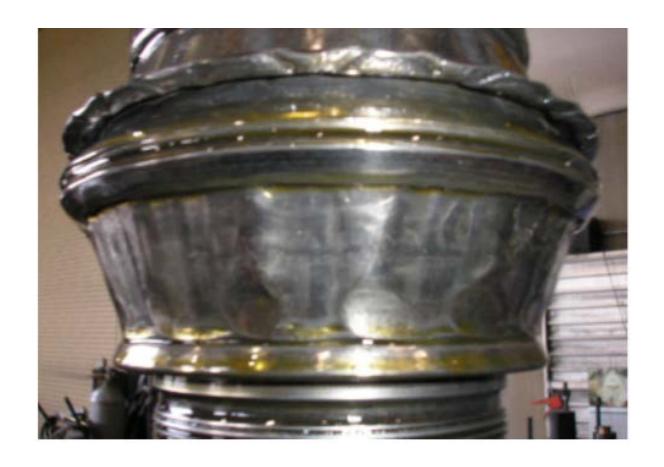
Plastic deformation of a pair of tapered roller bearings

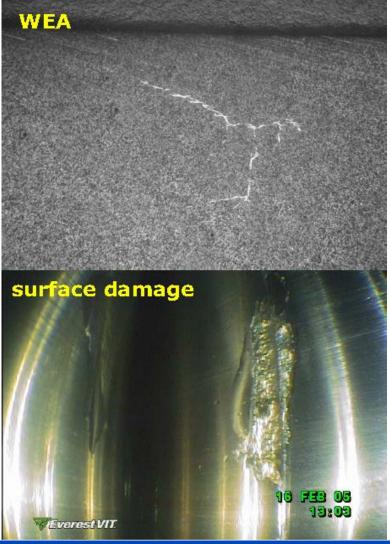
Bearing race white etching prior to spalling of race

Root Cause is the transient vibrational loading seen in high speed bearings

Up tower repair was perfected in the GRS shop then deployed to the field

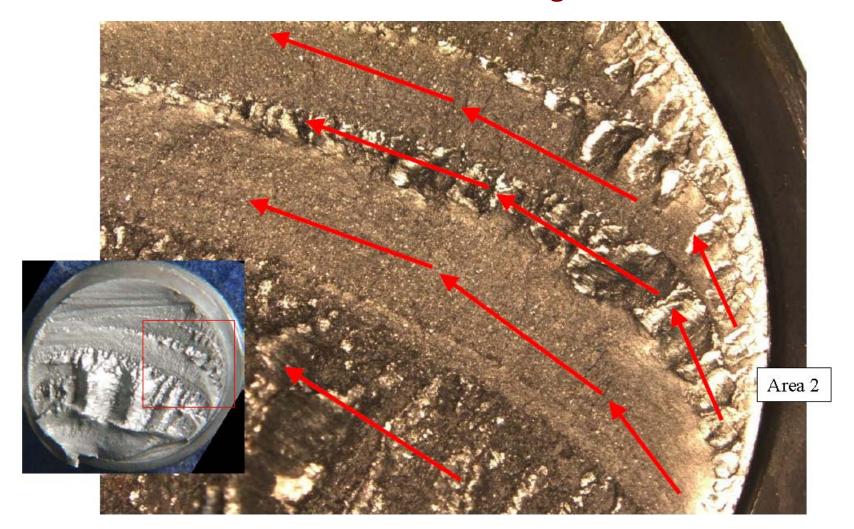
Gearbox case bolt failure after about 50% of the diameter was cracked the bolt sheared off causing a failure

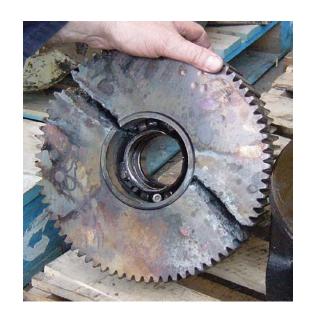
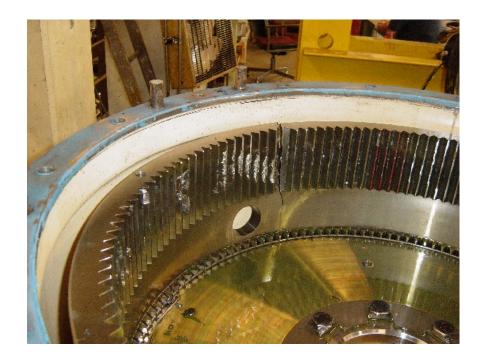
Broken Gear and Ring Gear – cracked in two pieces

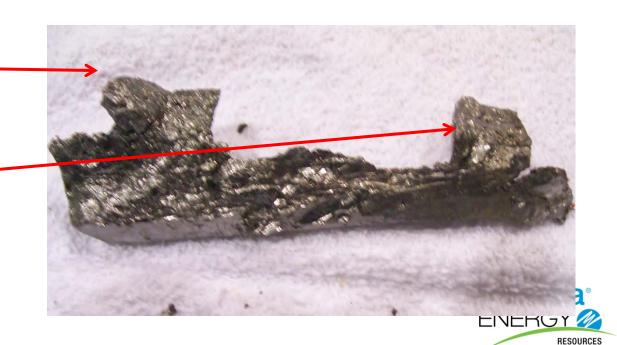
2 ring gear teeth cold welded together due to the energy of the failure

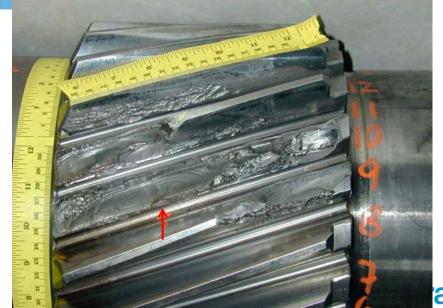
Overloading failure

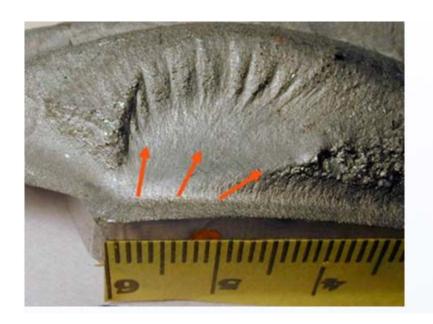
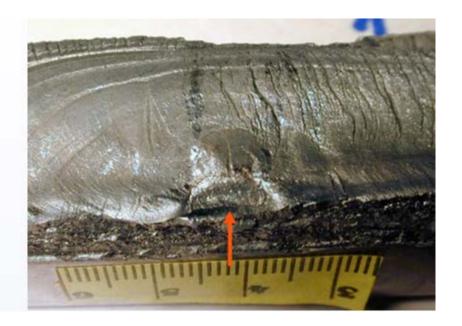
Inclusion failure

Non metallic inclusion usually aluminum or silica

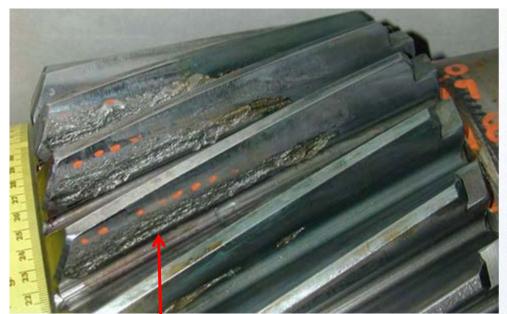
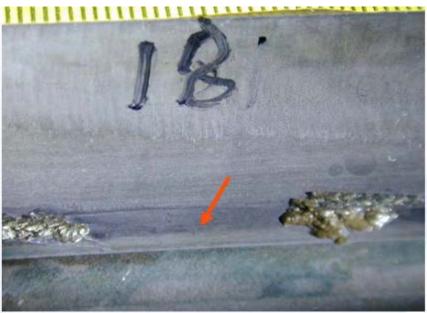
Macro spalling

One sided spalling can suggest an alignment issue
