**A computer-based inspection method for
determining
surface flaws of wind turbine**

Huiyi Zhang

July 03, 2013

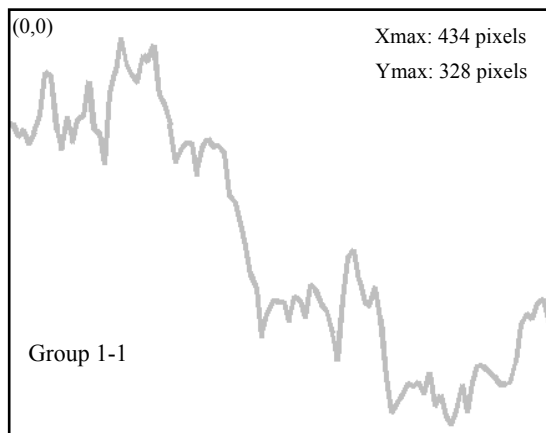
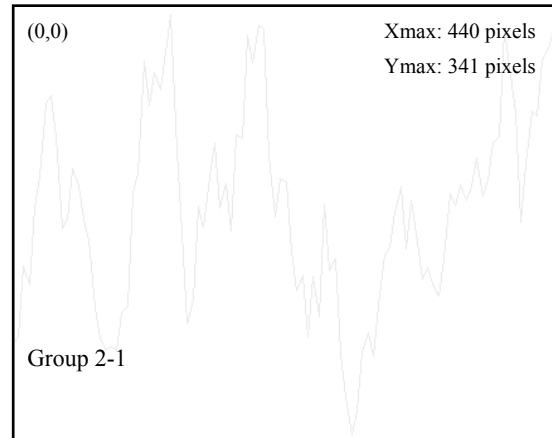
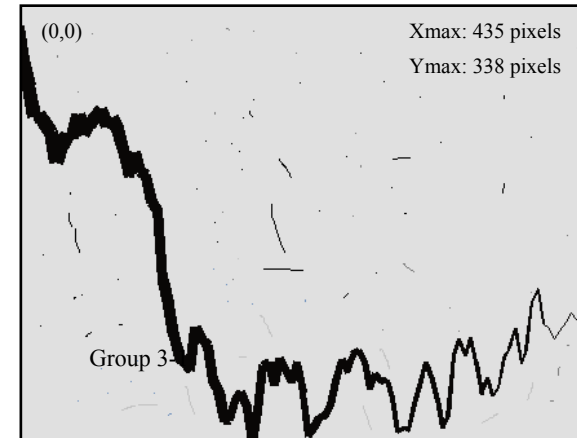
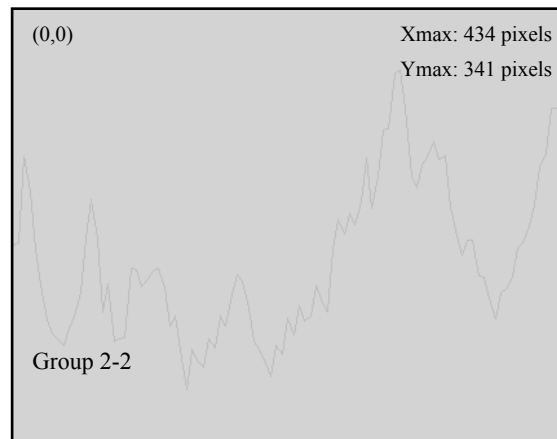
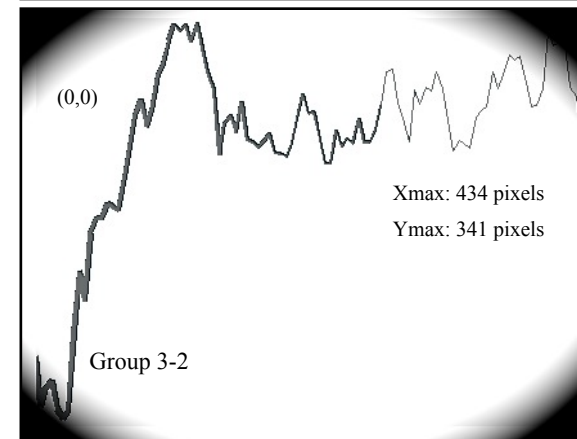
- Synthetic cracks

Characteristics may affect the detectability: (1) **Intensity level of pixels** (2) **Background noise** (3) **Uneven illumination**

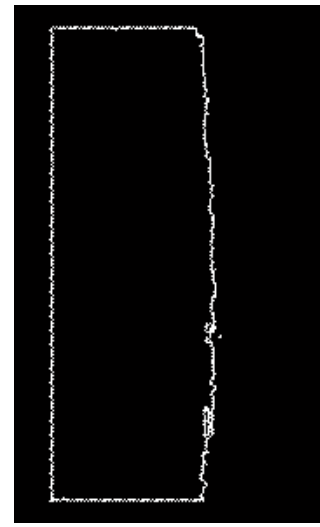
Rotate 30 CW

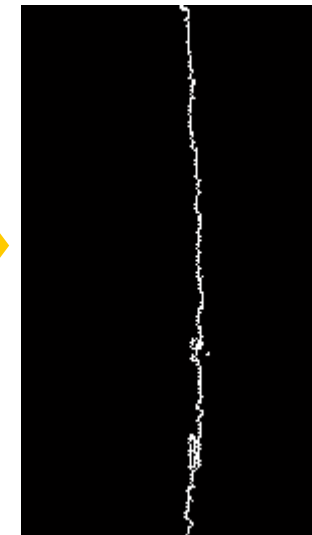
Trimmed off to the same size

*Same Threshold number – 0.8353

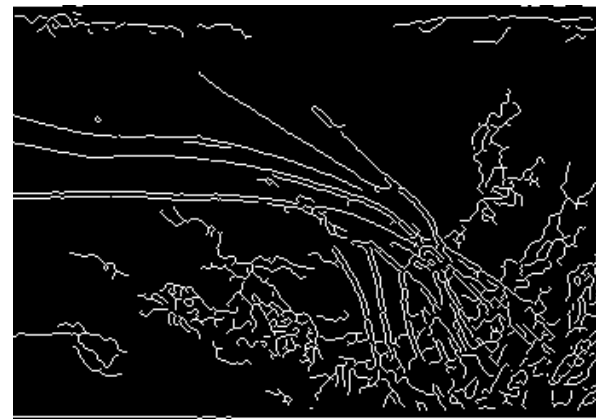
Canny with automatically selected threshold value

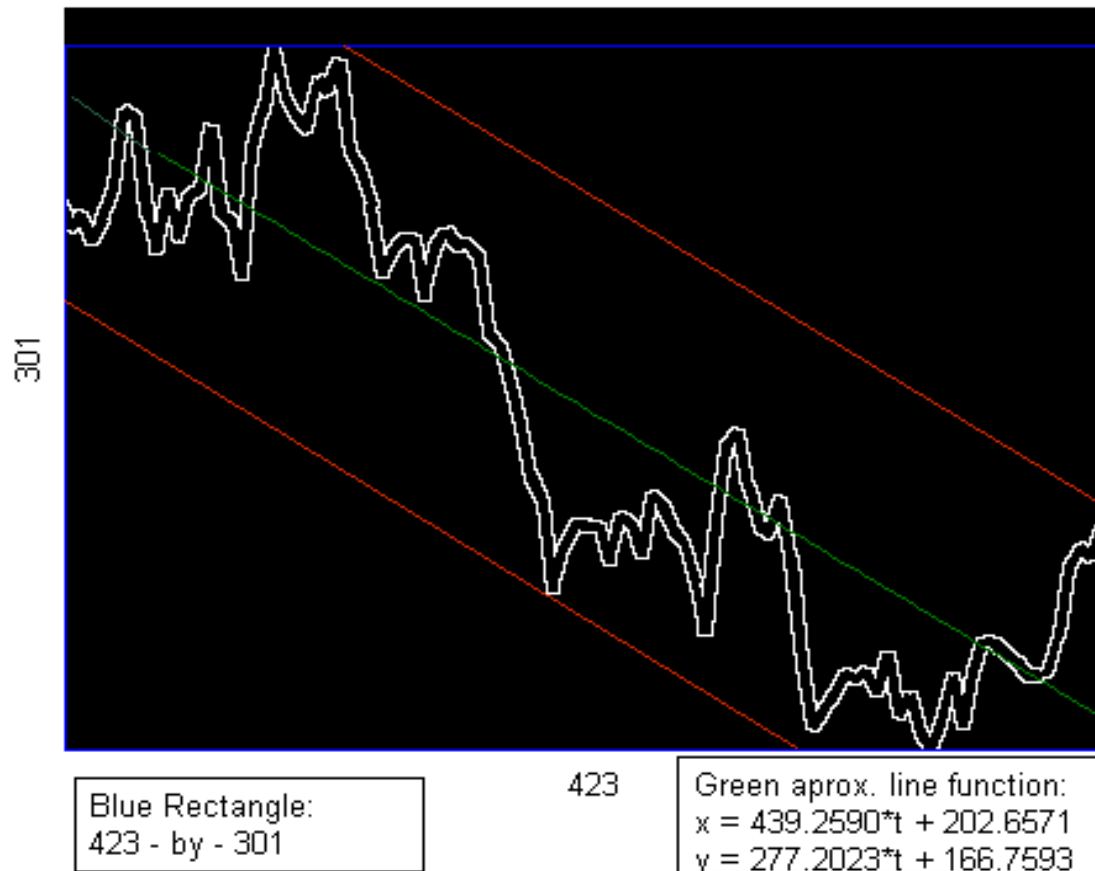
Quantifying the Synthetic Crack in Group 1 - 1

- Quantifying a crack

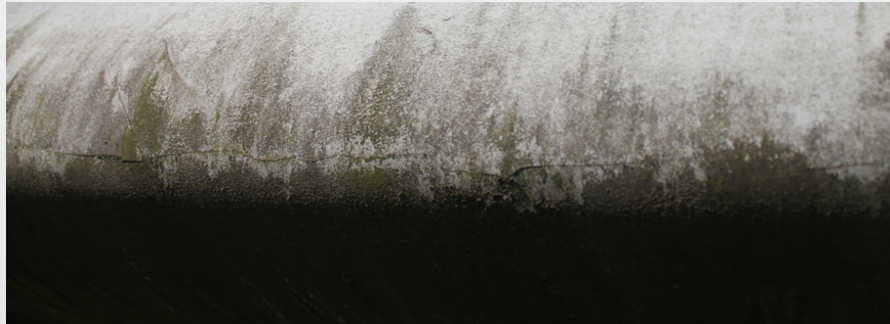
Gel coat cracks:

Severe Type 1 Error

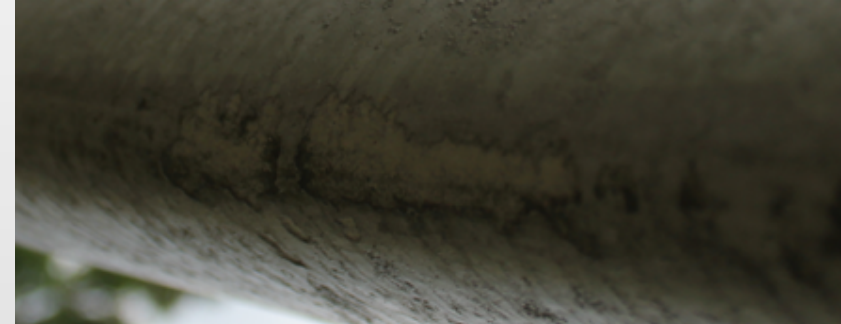
Leading edge erosion (GE banana shape blade)

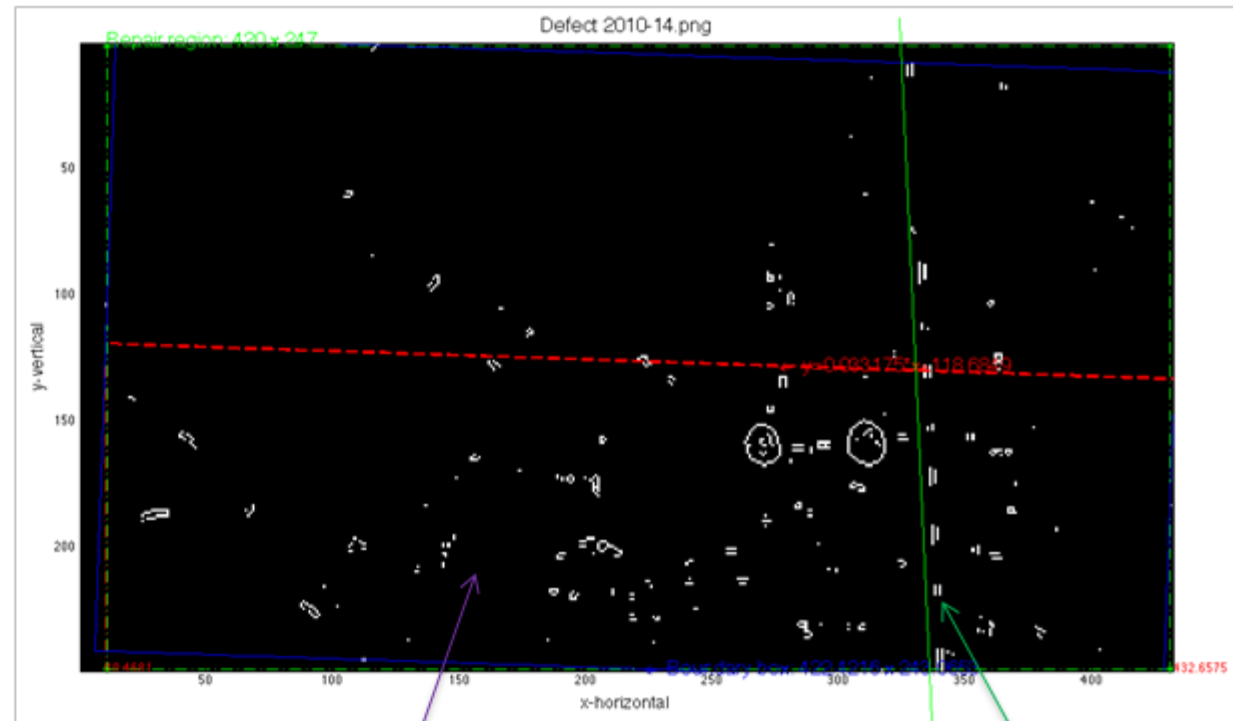
Ser.	14
Radius	18.8
Pos.	VK
PT in %	0
Größe	7
Anzahl	1
Schaden	Querriss

Boundary box along xy axes:

$$420 \times 247$$

Noises: dirt, insects, and so on.
It is important to define the characteristics of the noises first.

Crack was not recognized.

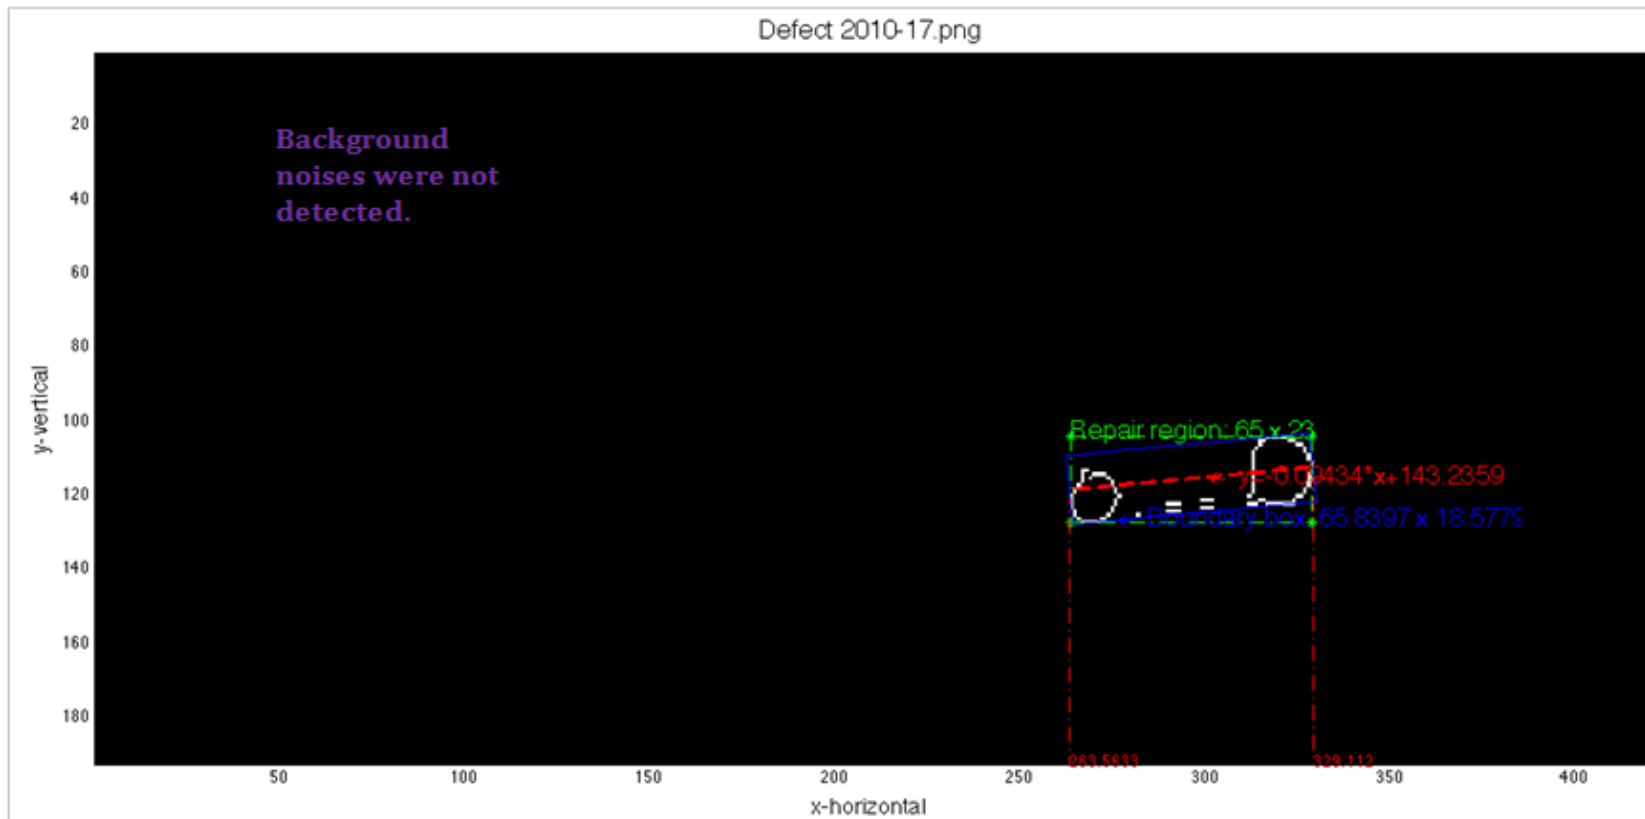
Ser.	Radius	Pos.	PT in %	Größe	Anzahl	Schaden
17	22.2-23.5	VK	0	7-12	5	Querrisse

Direction Line: $y = -0.09434 * x + 143.2359$ $x \in [263.5633, 329.112]$

Directional boundary box: 65.8397×18.5779 **Boundary box along xy axes:** 65×23

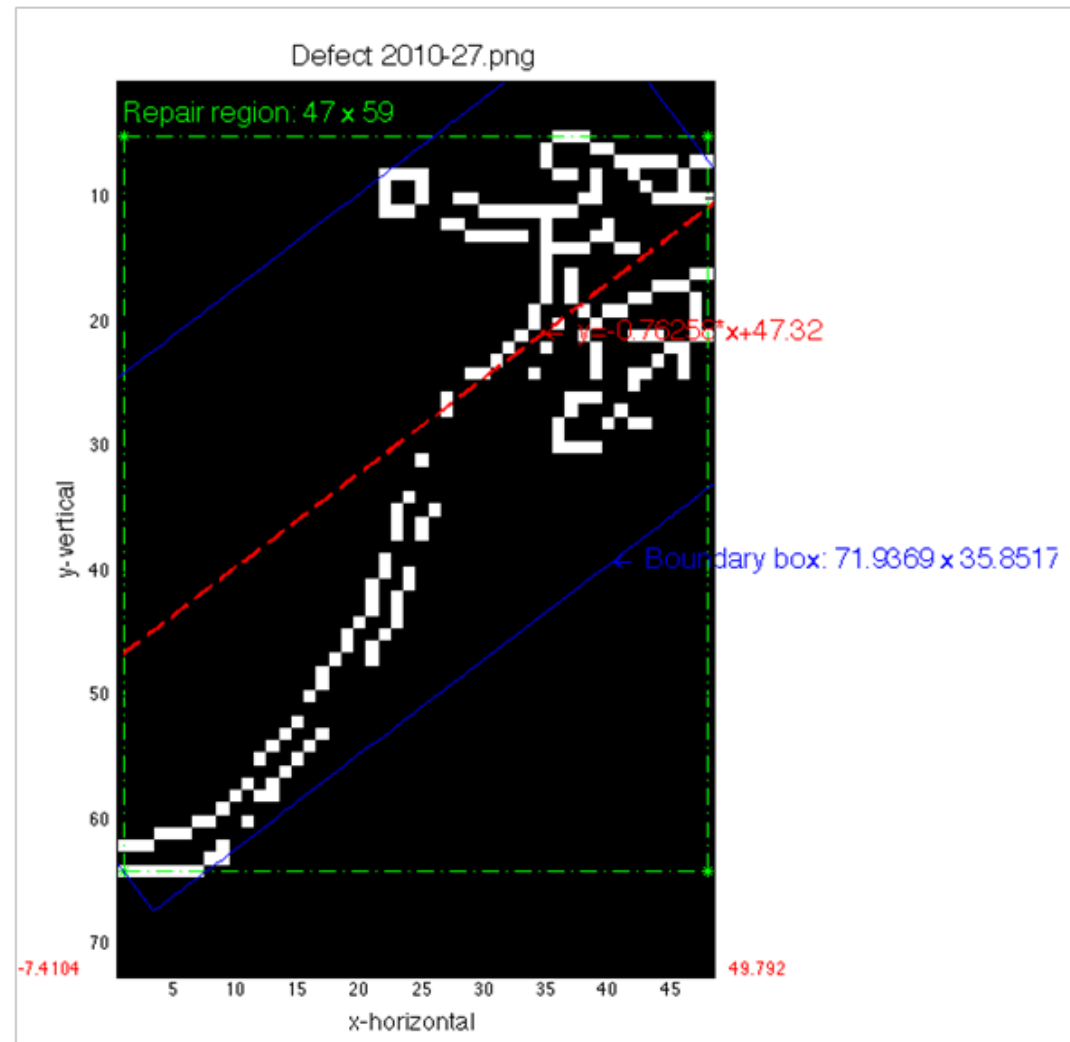
Ser.	27
Radius	33.9
Pos.	DS
PT in %	95
Größe	22
Anzahl	1
Schaden	Verzerrter Riss

Boundary box along xy axes:

47 x 59

Note: All the numbers are in pixels. It is necessary to know the camera info in order to convert into million meters. In addition, the location of the defect can be identified with the entire blade image No. 28 is not focused and the defect is not clear at all.

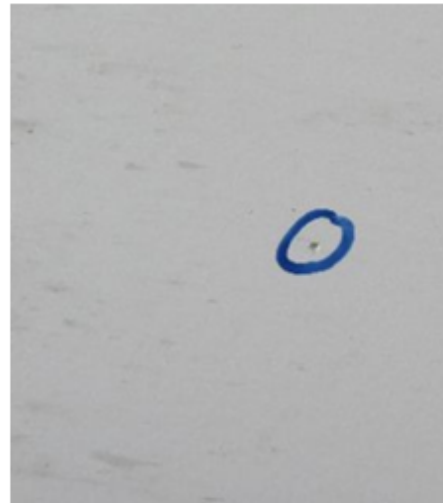
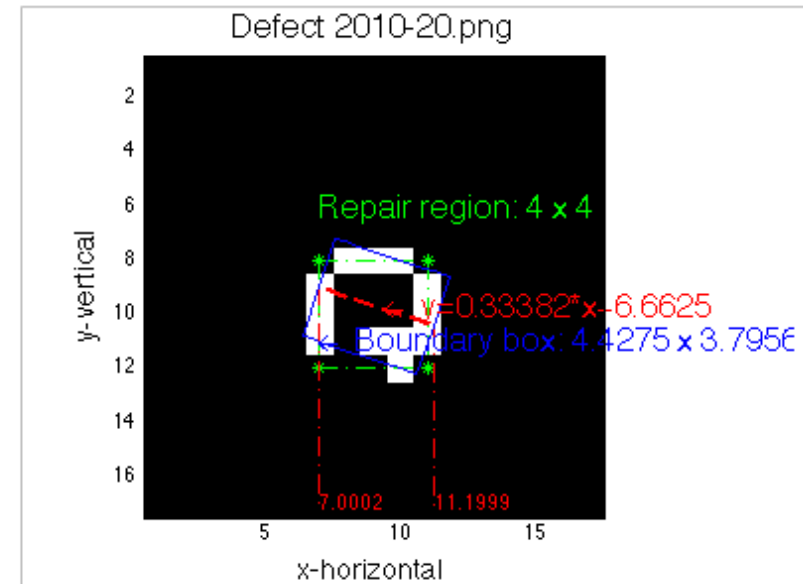
Ser.	20
Radius	28.5-29
Pos.	DS
PT in %	10-40
Größe	3-4
Anzahl	2
Schaden	Abplatzungen in der Beschichtung

Directional boundary box: 4.4275×3.7956

Boundary box along xy axes: 4×4

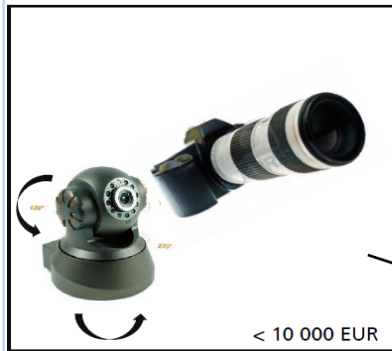
Hardware

Camera with telephoto lens on a pan-tilt module + notebook

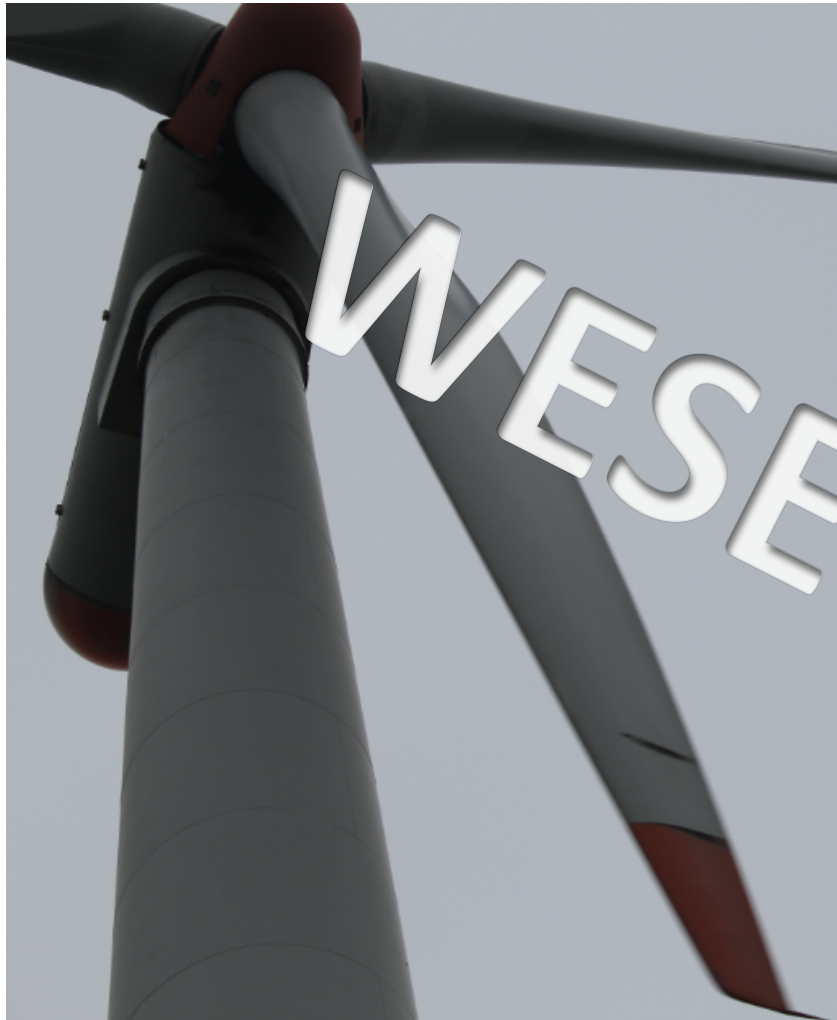
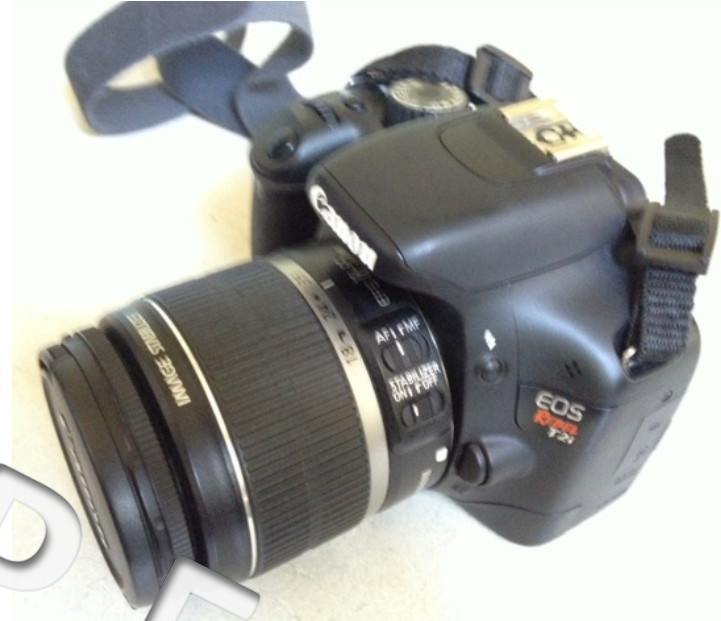
- Field test – Site 1
 - Cannot capture both side of the blade with a fixed position setup.

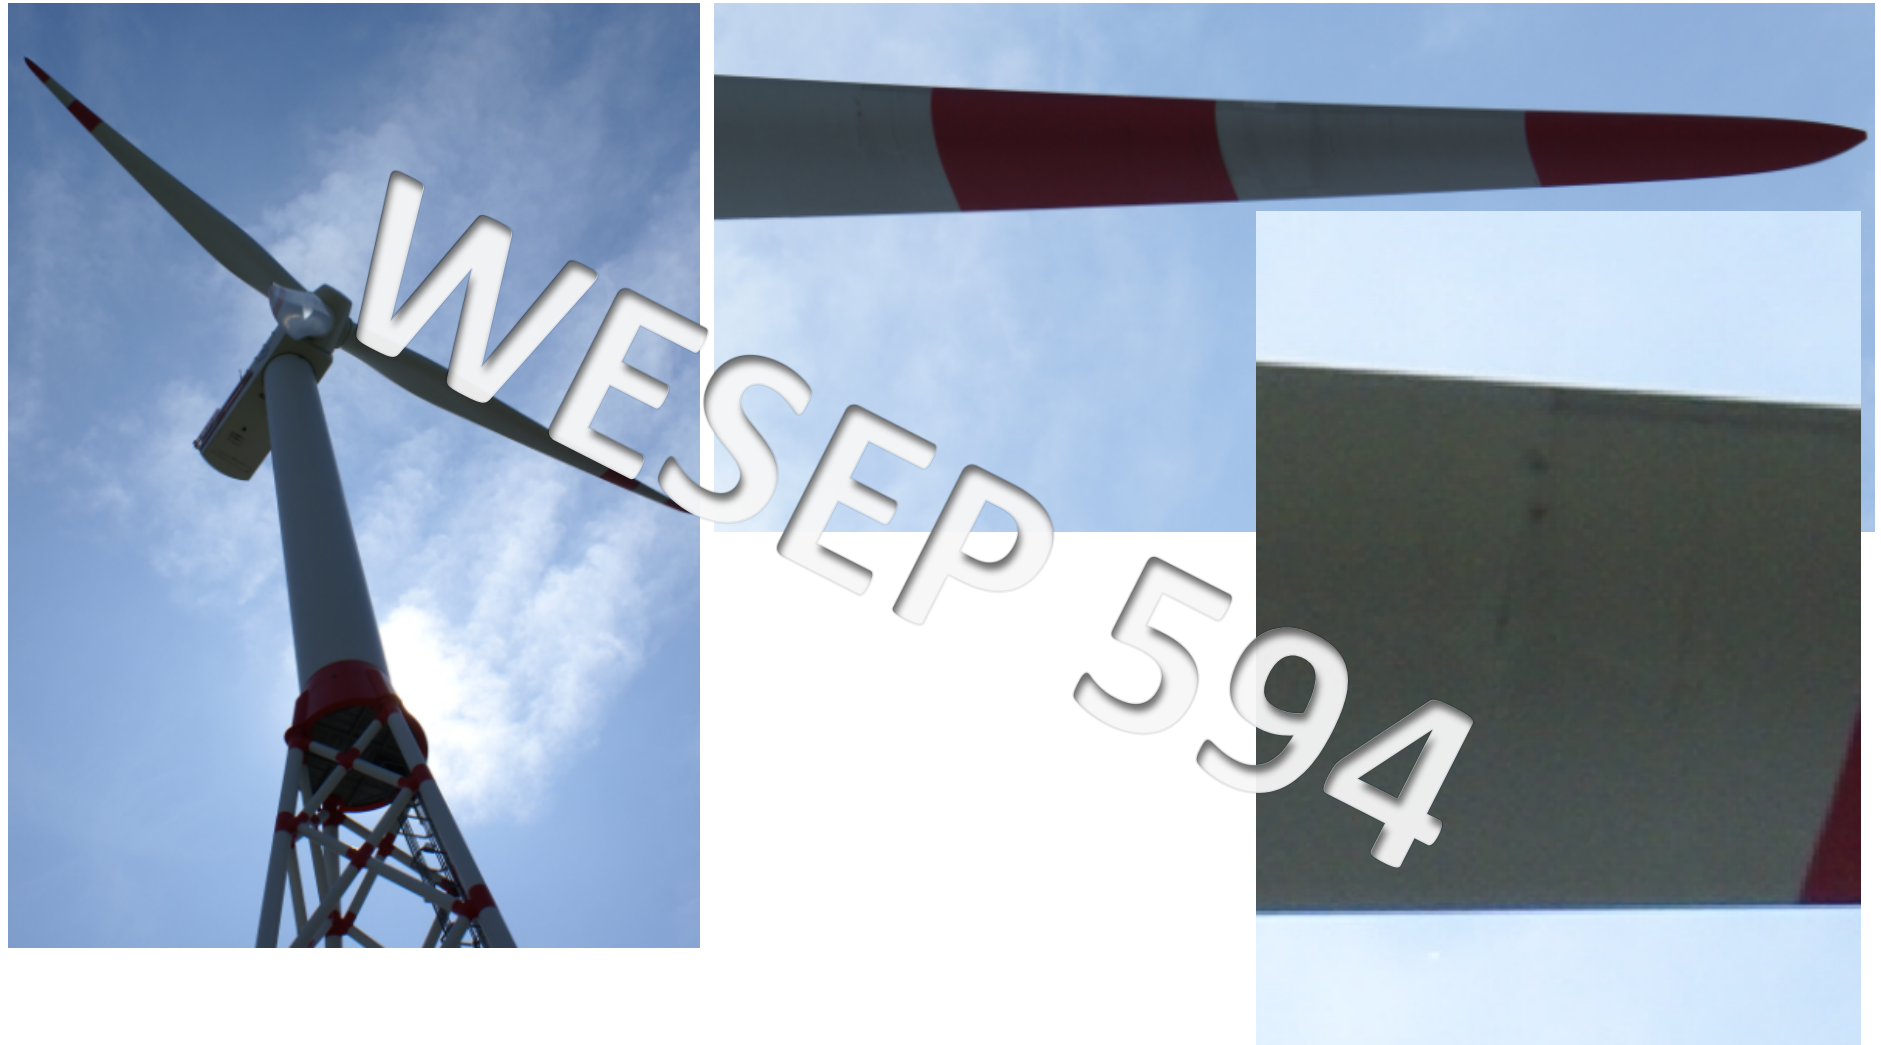
- Field test – Site 2
 - Visibility problem with hybrid tower and pre-bending blades.

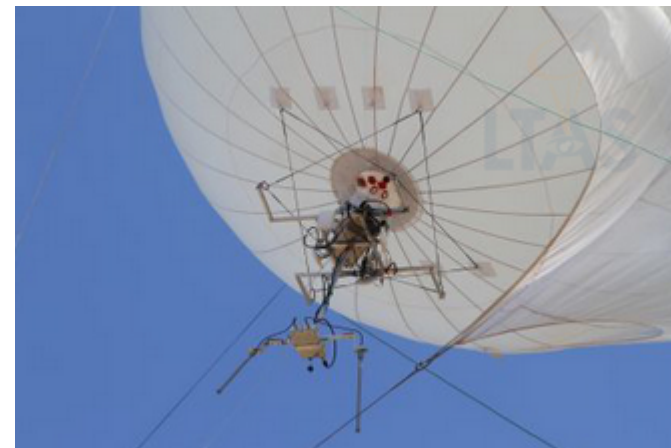
- NDI (or called NDE)
 - The image acquisition system will consider to carry thermal camera or other device to detect structural damages
- Aerodynamic study
 - Aerodynamic impact due to surface roughness
- Generator side (power output)
 - Health blades will reduce vibration and smooth the output
 - Reduce downtime
